**CVH**  
COLLEGE MILTON INDUSTRIAL ESTATE  
EAST KILBRIDE  
**19/09/2025**

# **FIELD BIOLOGY REPORT No: 72**

**Field Biologist: Chris Gahagan**

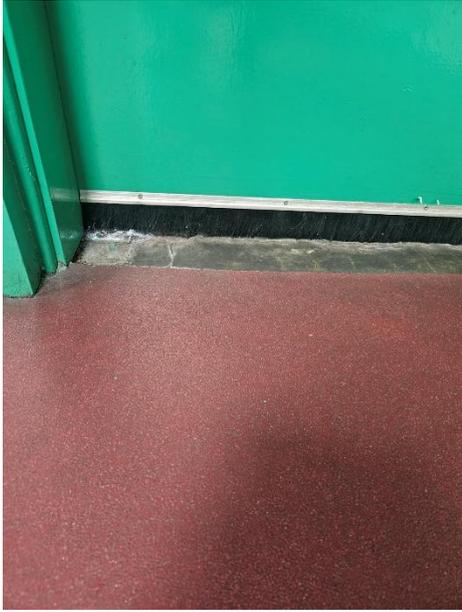
7. CANTEEN/KITCHEN			
<b>Observations</b>	7.1 Slight gap developing at the bottom corner of fire exit door.		
<b>Photographs</b>

<b>Recommendations</b>	Brush strip should be adjusted to more effectively proof door.		
<b>Action By</b>	<b>CLIENT</b>	<b>Date Completed</b>

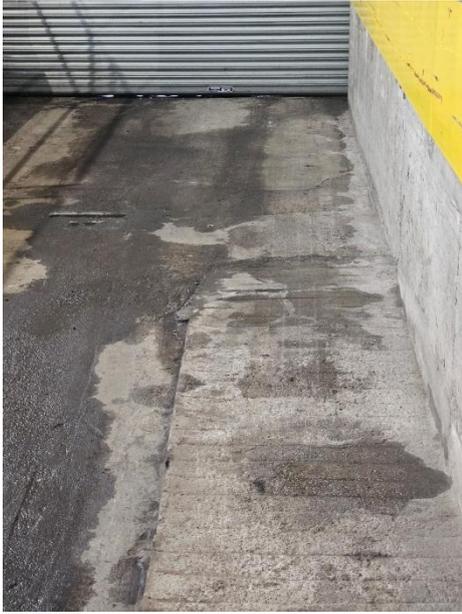
9. BASEMENT WAREHOUSE			
<b>Observations</b>	9.1 Gaps noted at base of roller shutter door.		
<b>Photographs</b>

<b>Recommendations</b>	Larger proofing strip required to reduce risk of pest ingress.
