**IFF**  
**LADYBURN WORKS**  
**GIRVAN**  
**20/03/2025**

**FIELD BIOLOGY REPORT No: 80**  
**Field Biologist: Chris Gahagan**

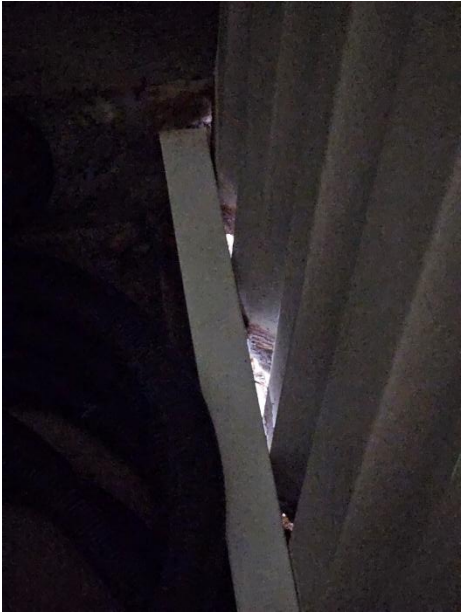
<b>10. IBC STORAGE AREA</b>			
<b>Observations</b>	10.1 Gaps noted at wall/floor junction at fire exit door near camfill.		
<b>Photographs</b>

<b>Recommendations</b>	These gaps should be sealed to reduce risk of pest ingress.		
<b>Action By</b>	<b>CLIENT</b>	<b>Action By</b>

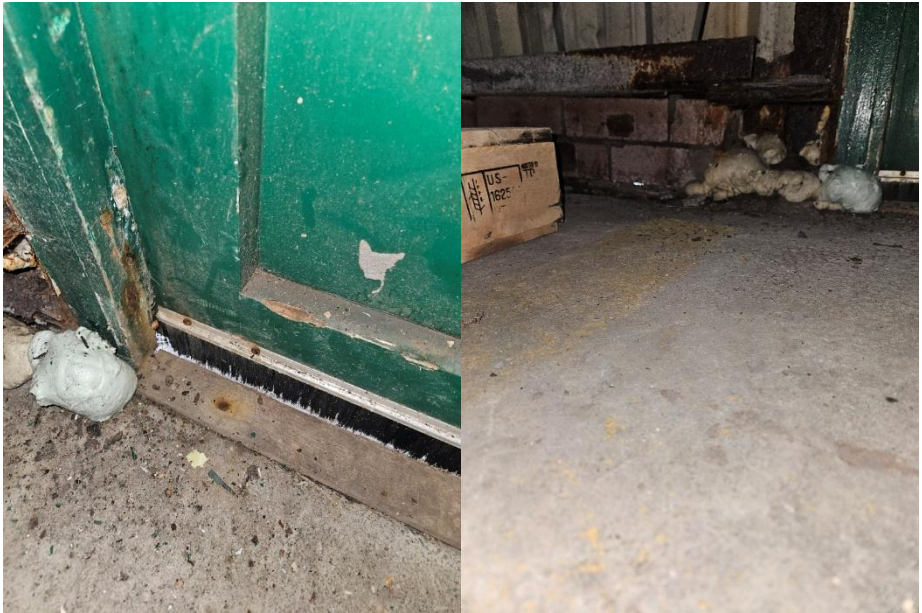
<b>Observations</b>	10.2 Gaps noted at base of fire exit door 9 and at wall/floor junction to the left hand side of door.		
<b>Photographs</b>

<b>Recommendations</b>	These gaps should be sealed to reduce risk of pest ingress.		
<b>Action By</b>	<b>CLIENT</b>	<b>Action By</b>

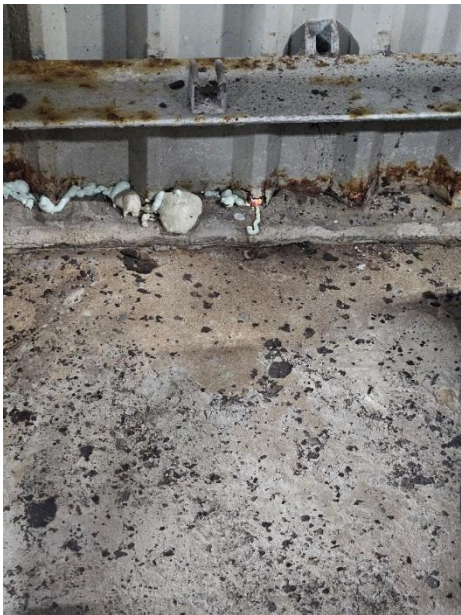
<b>Observations</b>	18.1 Gaps noted at wall/floor junctions behind racking area.		
<b>Photographs</b>

<b>Recommendations</b>	These gaps could be filled to reduce risk of pest ingress.		
<b>Action By</b>	<b>CLIENT</b>	<b>Date Completed</b>

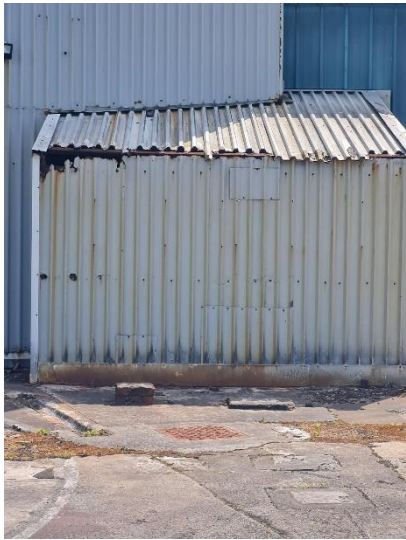
<b>Observations</b>	19.1 As per previous report, cladding damaged at rear of site. Gaps do not lead into building but could allow pest harbourage.		
---------------------	--	--	--

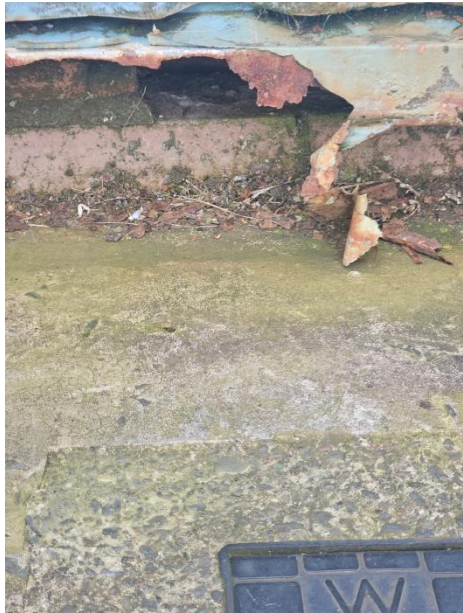
<b>Recommendations</b>	Repairs should be carried out to area.		
<b>Action By</b>	<b>CLIENT</b>	<b>Date Completed</b>	
<b>Observations</b>	19.2 Gap noted in brickwork under cladding to the right-hand side of ABA plant entry door.		
<b>Photographs</b>

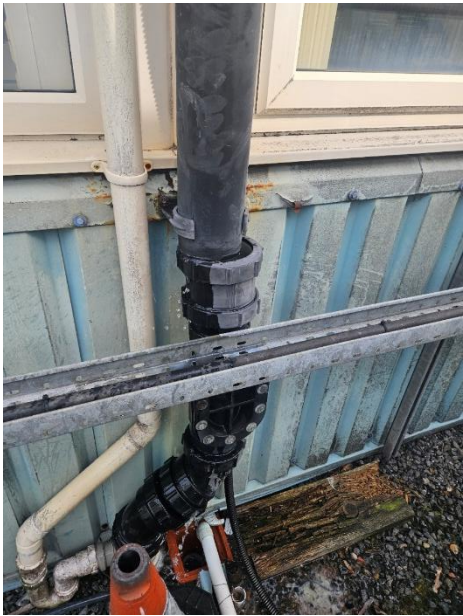
<b>Recommendations</b>	Repairs should be carried out to area.		
<b>Action By</b>	<b>CLIENT</b>	<b>Date Completed</b>	
<b>Observations</b>	19.3 Damage noted to downpipe at rear of lab/office area causing water to leak out and stagnate.

<b>Recommendations</b>	Repairs should be carried out to pipe to reduce risk of water encouraging pests.		
<b>Action By</b>	<b>CLIENT</b>	<b>Date Completed</b>
