**IFF**  
**LADYBURN WORKS**  
**GIRVAN**  
**24/06/2025**

## **FIELD BIOLOGY REPORT No: 81**

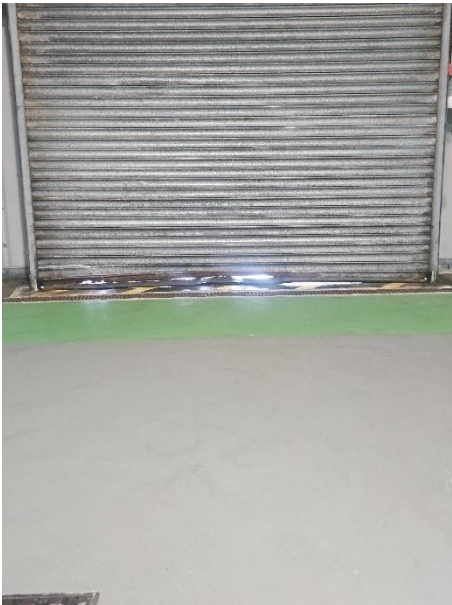
<b>6. GOODS IN WAREHOUSE</b>			
<b>Observations</b>	6.1 Roller door at bait station 3 noted to be damaged.

<b>Recommendations</b>	Repairs to door should be carried out to reduce risk of pest ingress.		
<b>Action By</b>	CLIENT	<b>Date Completed</b>

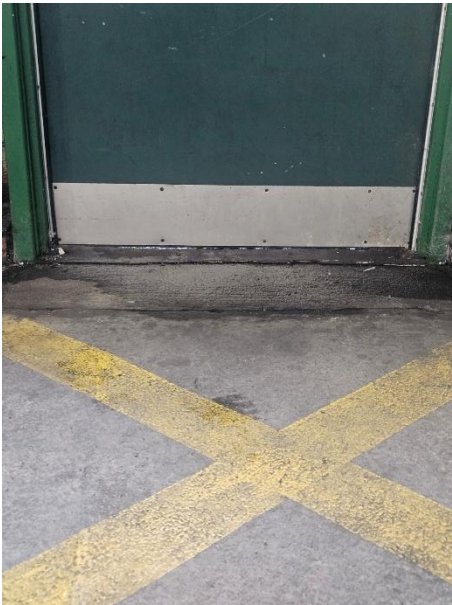
<b>13. GOODS OUT WAREHOUSE</b>			
<b>Observations</b>	13.1 Slight gap visible at base of fire exit door 5.

<b>Recommendations</b>	Brush strip installed externally. Strip needs adjusted to more effectively proof door.		
<b>Action By</b>	<b>CLIENT</b>	<b>Date Completed</b>

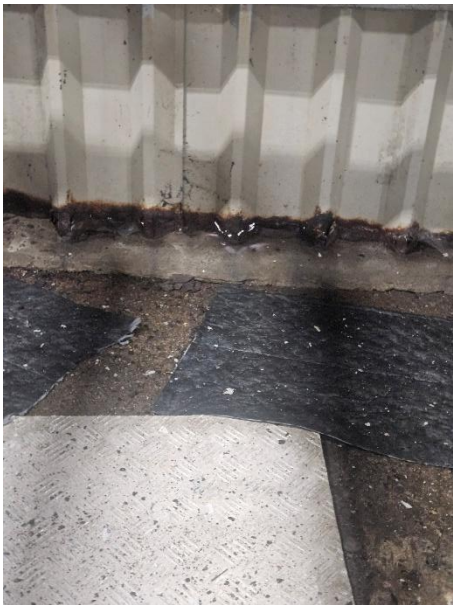
17. STORAGE BUILDING (COMPRESSOR SHED)			
<b>Observations</b>	18.1 Gaps noted at wall/floor junctions along wall facing shoreline.		
<b>Photographs</b>

<b>Recommendations</b>	These gaps could be filled to reduce risk of pest ingress.		
<b>Action By</b>	<b>CLIENT</b>	<b>Date Completed</b>

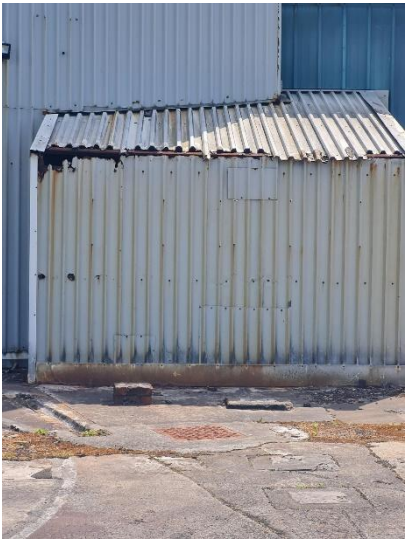
18. EXTERNAL AREAS	
<b>Observations</b>	19.1 As per previous report, cladding damaged at rear of site. Gaps do not lead into building but could allow pest harbourage.

<b>Recommendations</b>	Repairs should be carried out to area.		
<b>Action By</b>	<b>CLIENT</b>	<b>Date Completed</b>
