**IFF**  
**LADYBURN WORKS**  
**GIRVAN**  
**17/09/2025**

## **FIELD BIOLOGY REPORT No: 82**

**Field Biologist: Chris Gahagan**

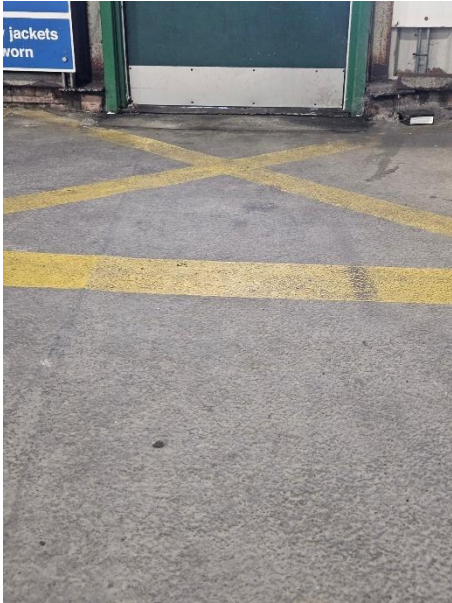
13. GOODS OUT WAREHOUSE			
<b>Observations</b>	13.1 As per previous report, slight gap visible at base of fire exit door 5.		
<b>Photographs</b>

<b>Recommendations</b>	Brush strip installed externally. Strip needs adjusted to more effectively proof door.		
<b>Action By</b>	<b>CLIENT</b>	<b>Date Completed</b>

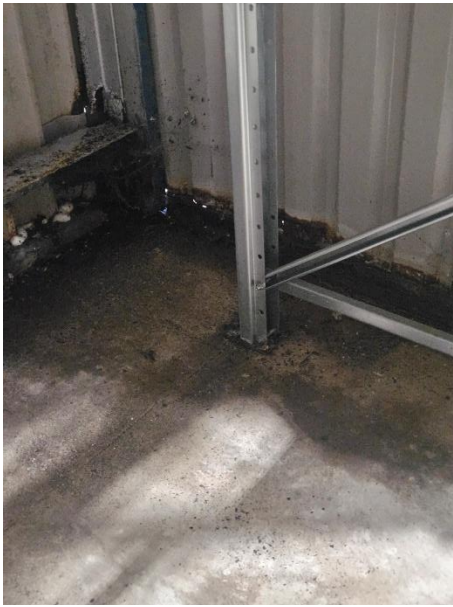
17. STORAGE BUILDING (COMPRESSOR SHED)	
<b>Observations</b>	18.1 Gaps noted at wall/floor junctions along wall facing shoreline.

<b>Recommendations</b>	These gaps could be filled to reduce risk of pest ingress.		
<b>Action By</b>	<b>CLIENT</b>	<b>Date Completed</b>

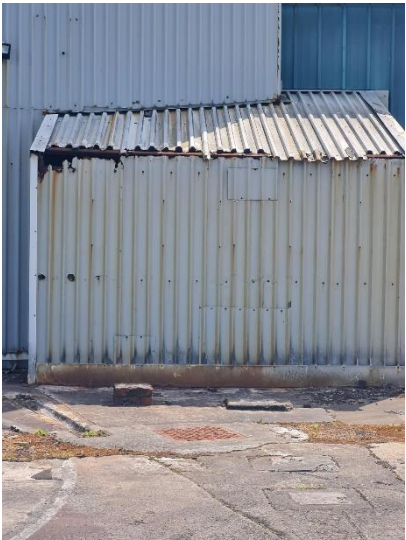
18. EXTERNAL AREAS			
<b>Observations</b>	19.1 As per previous report, cladding damaged at rear of site. Gaps do not lead into building but could allow pest harbourage.		
<b>Photographs</b>

<b>Recommendations</b>	Repairs should be carried out to area.		
<b>Action By</b>	<b>CLIENT</b>	<b>Date Completed</b>
