**BIOMAR**

**30/01/2025**

## **FIELD BIOLOGY REPORT No: 6**

**Field Biologist: Chris Gahagan**

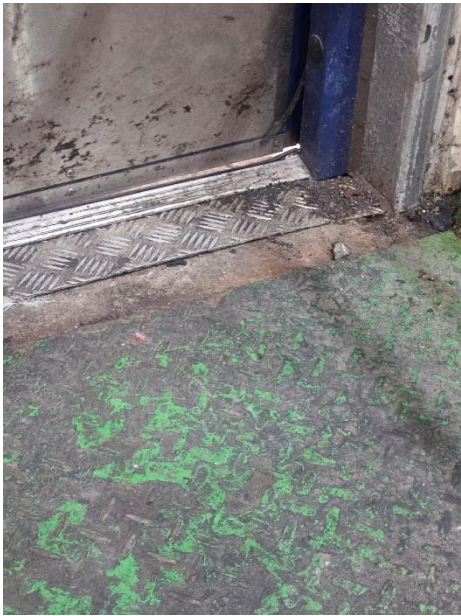
<b>6. PRODUCTION AREAS</b>			
<b>Observations</b>	6.1 Fire door not closing fully at bait station 24.

<b>Recommendations</b>	Repairs should be carried out to reduce risk of pest ingress.		
<b>Action By</b>	<b>CLIENT</b>	<b>Date Completed</b>

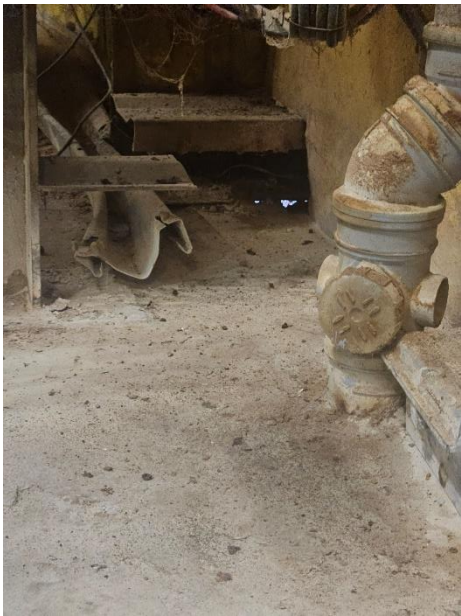
<b>7. WAREHOUSE NO. 1</b>			
<b>Observations</b>	7.1 Gap noted at wall/floor junction where beam enters building at big bag discharger dust extraction panel at bait 75.		
<b>Photographs</b>

<b>Recommendations</b>	Gap should be filled to reduce risk of pest ingress.		
<b>Action By</b>	<b>CLIENT</b>	<b>Date Completed</b>

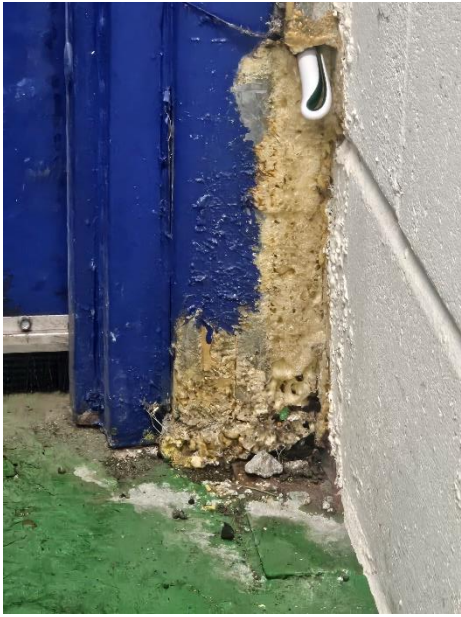
9. WAREHOUSE NO 2			
<b>Observations</b>	9.1 As per previous report, gap developing at right hand side of doorframe at D4.		
<b>Photographs</b>

<b>Recommendations</b>	Gap should be sealed to reduce risk of pest ingress.		
<b>Action By</b>	<b>CLIENT</b>	<b>Date Completed</b>

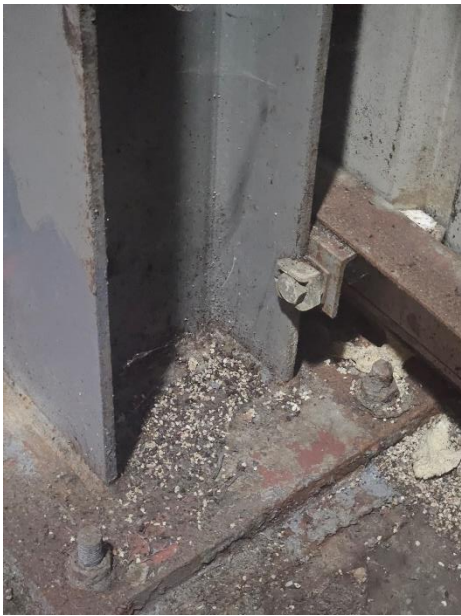
10. INTERNAL SILOS			
<b>Observations</b>	10.1 Old mouse droppings and damage noted throughout.		
<b>Photographs</b>

<b>Recommendations</b>	Historic rodent evidence should be cleaned away to allow raid identification of fresh activity.		
<b>Action By</b>	<b>CLIENT</b>	<b>Date Completed</b>	
<b>Observations</b>	10.2 Gap noted at base of roller door.

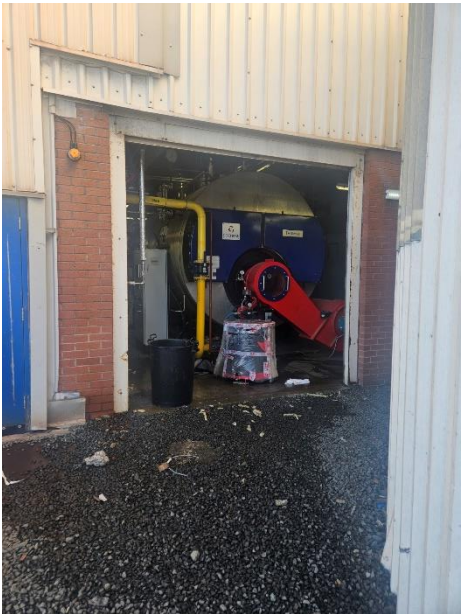
11. BOILER HOUSES			
<b>Observations</b>	11.1 Roller shutter door lying open.		
<b>Photographs</b>

<b>Recommendations</b>	Doors should be closed when not in use to reduce risk of pest ingress.		
<b>Action By</b>	<b>CLIENT</b>	<b>Date Completed</b>	
<b>Observations</b>	11.2 Gap noted at base of fire exit door. Proofing strip damaged.

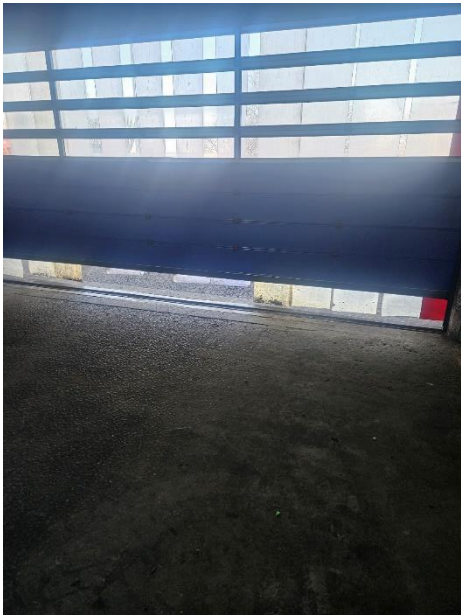
<b>13. WAREHOUSE A- E</b>	
<b>Observations</b>	13.1 Roller door A found to be lying open.

<b>Recommendations</b>	Doors should be closed when not in use to prevent pest ingress.		
<b>Action By</b>	<b>CLIENT</b>	<b>Date Completed</b>	
<b>Observations</b>	13.2 Roller door B lying open and unattended.		
<b>Photographs</b>

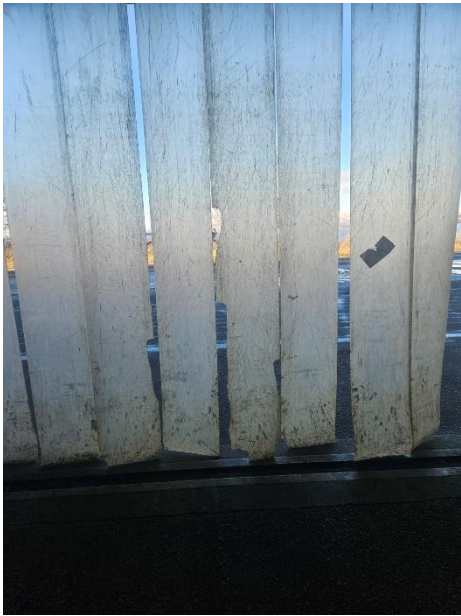
<b>Recommendations</b>	Doors should be closed when not in use to prevent pest ingress.		
<b>Action By</b>	<b>CLIENT</b>	<b>Date Completed</b>	
<b>Observations</b>	13.3 Strip curtains noted to be damaged at roller door D. Door also lying open and unattended.

<b>Recommendations</b>	Doors should be closed when not in use to prevent pest ingress. Damaged sections of strip curtain should be replaced.		
<b>Action By</b>	<b>CLIENT</b>	<b>Date Completed</b>

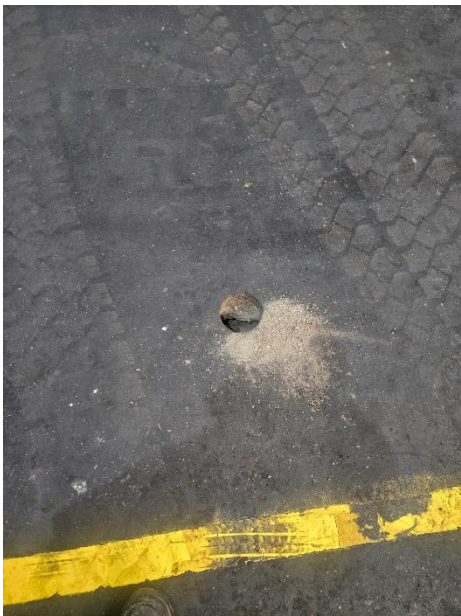
<b>14. WAREHOUSE F</b>			
<b>Observations</b>	14.1 Hole noted in floor which could allow pest harbourage.		
<b>Photographs</b>

<b>Recommendations</b>	Hole should be sealed to reduce risk of encouraging pests.		
<b>Action By</b>	<b>CLIENT</b>	<b>Date Completed</b>

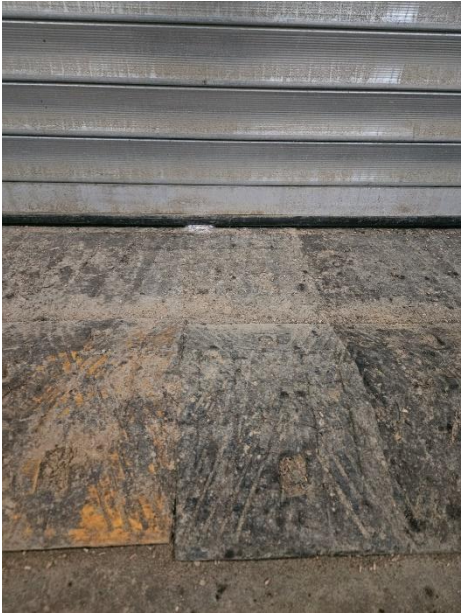
<b>Recommendations</b>	Doors should be closed when not in use. Pigeon removal could be carried out by Excel at an additional cost.		
<b>Action By</b>	<b>CLIENT</b>	<b>Date Completed</b>	
<b>Observations</b>	15.3 Gap noted in the centre of roller door of shed R3.

<b>Recommendations</b>	New section of brush strip may be required to reduce risk of pest ingress.		
<b>Action By</b>	<b>CLIENT</b>	<b>Date Completed</b>

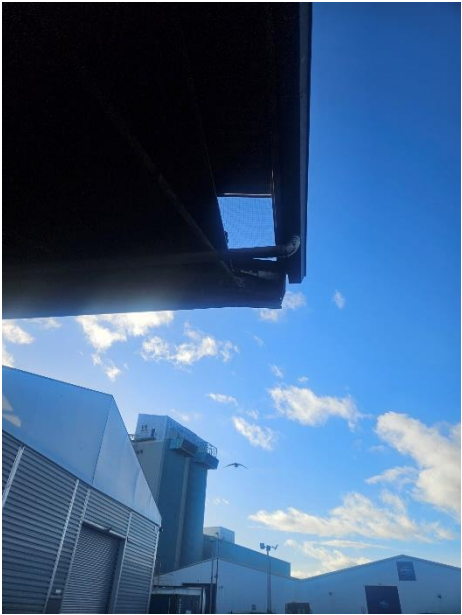
16. EXTERNAL AREAS			
<b>Observations</b>	16.1 Cladding noted to be missing from canopy which could allow bird access to void behind netting.		
<b>Photographs</b>

<b>Recommendations</b>	Repairs required to exclude birds from area.		
<b>Action By</b>	<b>CLIENT</b>	<b>Date Completed</b>
