BIOMAR

FIELD BIOLOGY REPORT No: 7

Field Biologist: Chris Gahagan

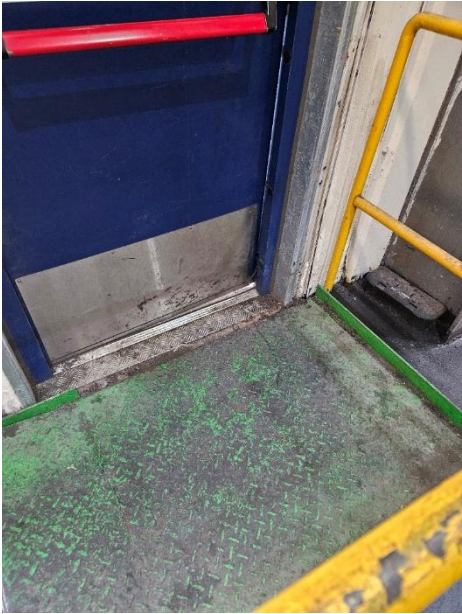
6. PRODUCTION AREAS			
Observations	6.1 Fire door lying partially open.

Recommendations	Doors should be closed when not in use to reduce risk of pest ingress.		
Action By	CLIENT	Date Completed

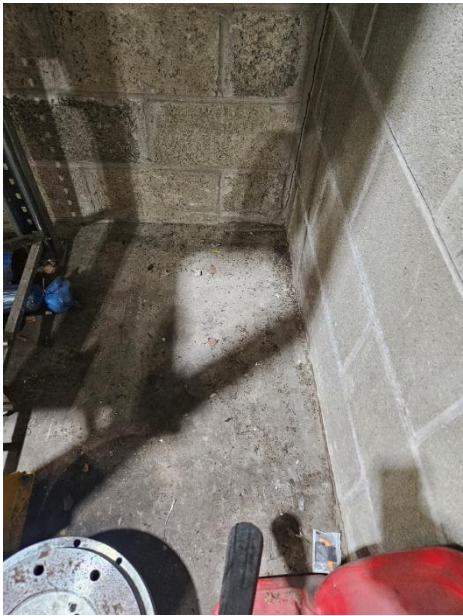
9. WAREHOUSE NO 2	
Observations	9.1 Old mouse droppings present in several areas around wall floor junctions.

Recommendations	Old droppings should be removed to allow quicker identification of fresh pest activity.		
Action By	CLIENT	Date Completed

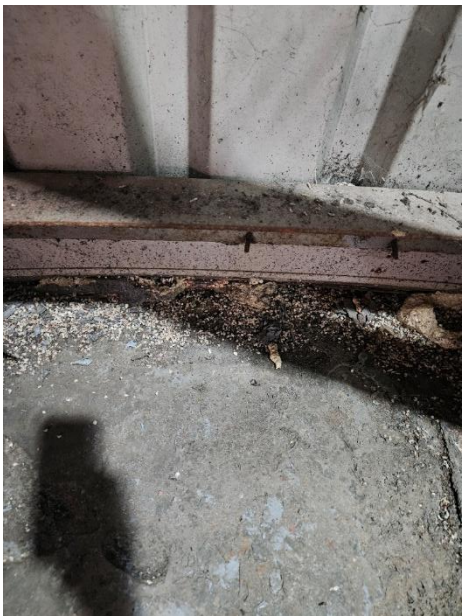
10. INTERNAL SILOS			
Observations	10.1 Old mouse droppings and damage noted throughout.		
Photographs

Recommendations	Historic rodent evidence should be cleaned away to allow rapid identification of fresh activity.		
Action By	CLIENT	Date Completed	
Observations	10.2 Gap noted at wall/floor junctions.

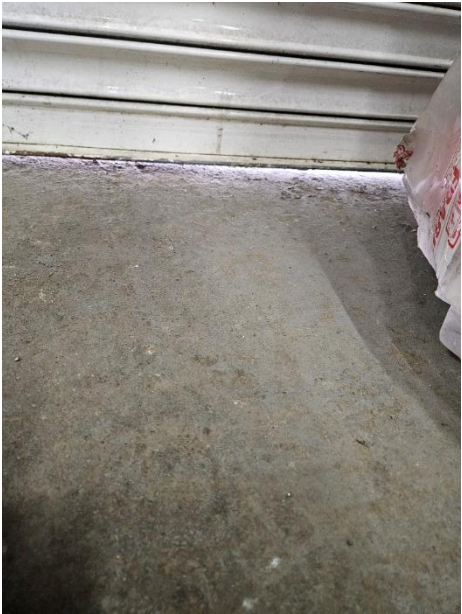
11. BOILER HOUSES			
Observations	11.1 Gap noted at base of roller door of boiler room 2.		
Photographs

Recommendations	Proofing strip could be installed to reduce risk of allowing pest ingress.		
Action By	CLIENT	Date Completed

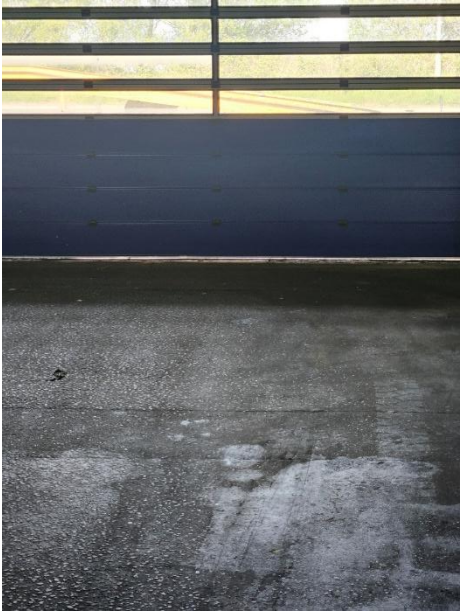
Observations	13.1 Gap noted at base of roller shutter door of A warehouse.		
Photographs

Recommendations	Proofing strip could be installed to reduce risk of pest ingress.		
Action By	CLIENT	Date Completed	
Observations	13.2 Gaps noted at bottom of roller door of B warehouse.		
Photographs	 		
Recommendations	These gaps should be proofed to reduce risk of pest ingress.		
Action By	CLIENT	Date Completed	
Observations	13.3 Strip curtains noted to have been removed from roller doors.

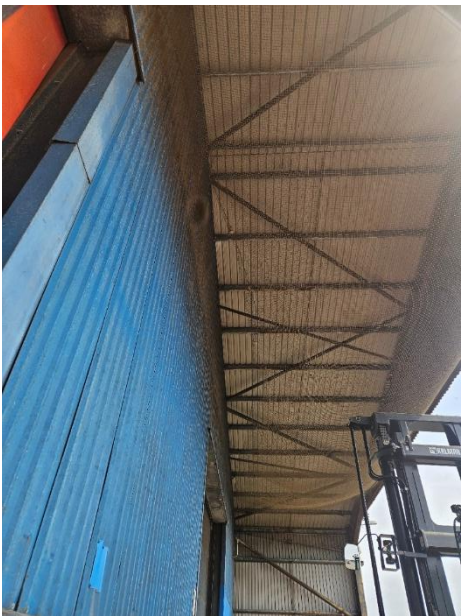
14. WAREHOUSE F			
Observations	14.1 Netting damaged at external canopy at rear of warehouse.		
Photographs

Recommendations	Repairs should be carried out to exclude birds from canopy.		
Action By	CLIENT	Date Completed

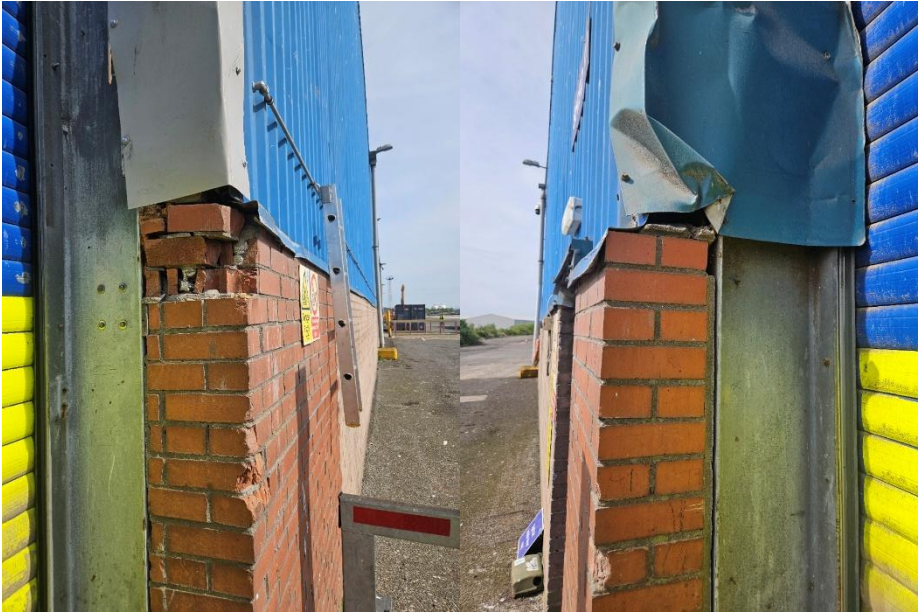
15. SHEDS R1-R3	
Observations	15.1 Impact damage noted to cladding and brickwork around door frame of shed R1.

Recommendations	Repairs required to ensure pests cannot gain access to shed via gaps exposed by damage.		
Action By	CLIENT	Date Completed	
Observations	15.2 Gap present at the bottom corner of roller door of shed R2		
Photographs

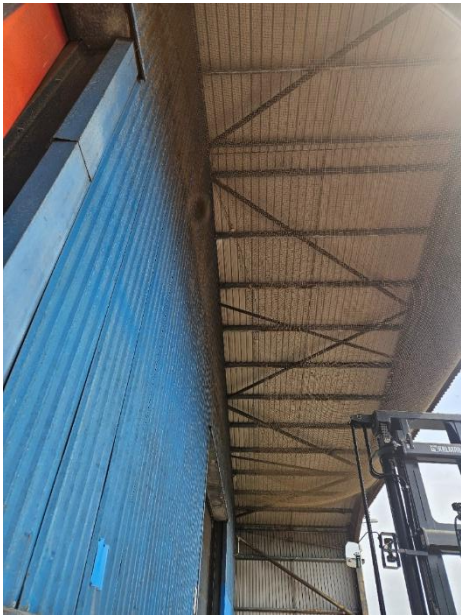
16. EXTERNAL AREAS	
Observations	16.1 as stated above, damaged netting noted at warehouse F canopy.

Recommendations	Repairs required to exclude birds from area.		
Action By	CLIENT	Date Completed
