BIOMAR

North Shore Road

25/07/2025

FIELD BIOLOGY REPORT No: 8

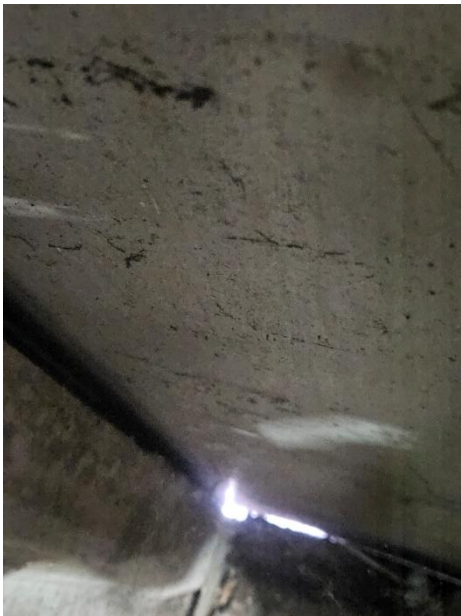
7. WAREHOUSE NO. 1			
Observations	7.1 Gap noted at the rear of fast action door to the left hand side.		
Photographs

Recommendations	Gap should be filled to reduce risk of pest ingress.		
Action By	CLIENT	Date Completed

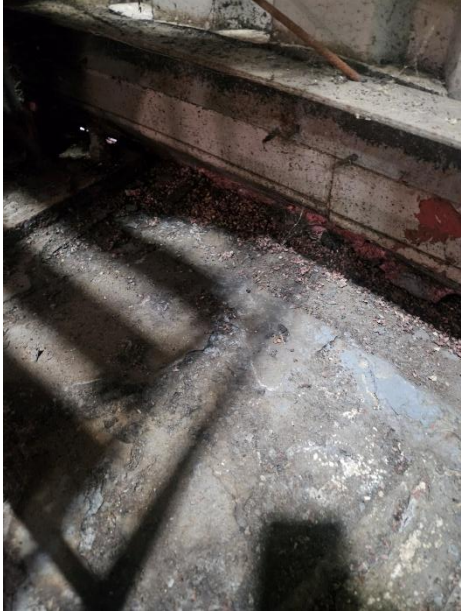
10. INTERNAL SILOS			
Observations	10.1 Old mouse droppings and damage noted throughout.		
Photographs

Recommendations	Historic rodent evidence should be cleaned away to allow raid identification of fresh activity.		
Action By	CLIENT	Date Completed	
Observations	10.2 Gap noted at base of roller door.		
Photographs

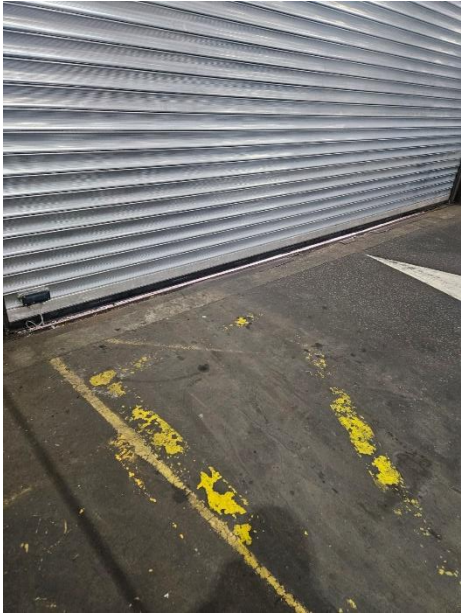
Observations	13.1 Roller door B noted to have a gap at its base.		
Photographs

Recommendations	Repairs to door required to ensure pests cannot gain access.		
Action By	CLIENT	Date Completed

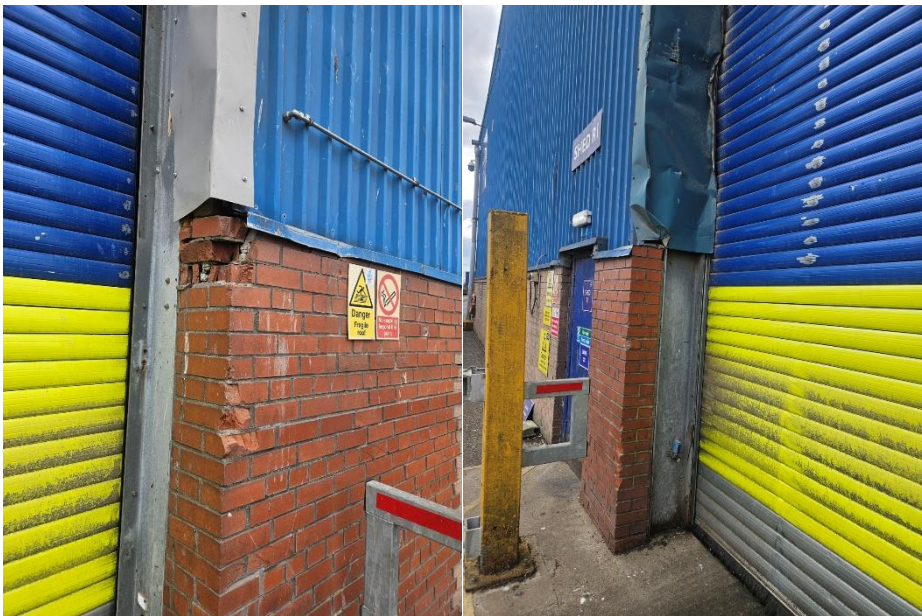
15. SHEDS R1-R3			
Observations	15.1 Gaps noted between brickwork and cladding around shed R1 door.		
Photographs

Recommendations	Gaps should be sealed to reduce risk of pest ingress.		
Action By	CLIENT	Date Completed
