BIOMAR
North Shore Road
Grangemouth
24/10/2025

FIELD BIOLOGY REPORT No: 9

Field Biologist: Chris Gahagan

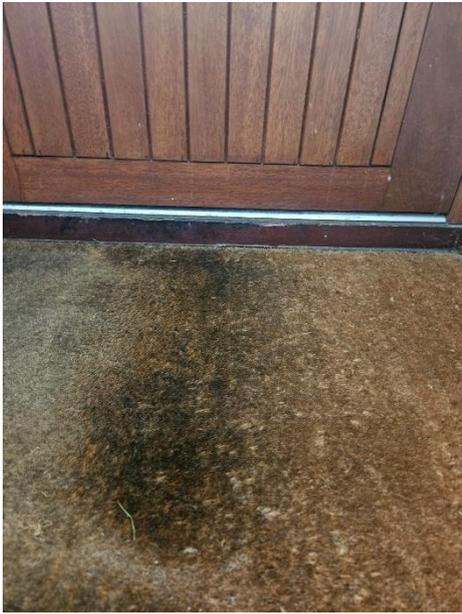
2. LAB/OFFICE BLOCK			
Observations	2.1 Gap noted at base of entry door.		
Photographs

Recommendations	Brush strip should be installed to reduce risk of pest ingress.		
Action By	CLIENT	Date Completed

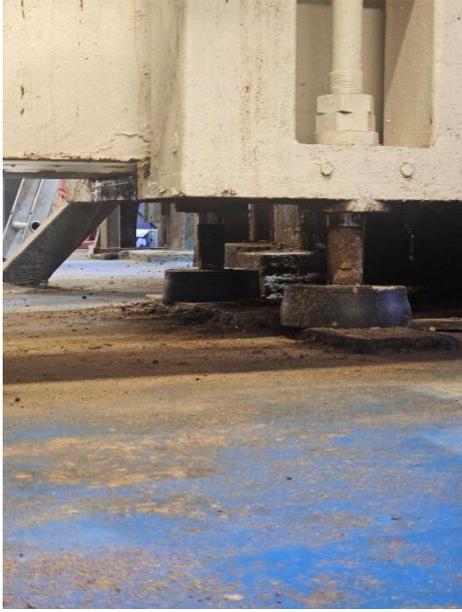
6. PRODUCTION AREAS			
Observations	6.1 Product debris noted in large quantities around machinery.		
Photographs

Recommendations	Regular cleaning should reduce risk of product debris encouraging pest activity.		
Action By	CLIENT	Date Completed

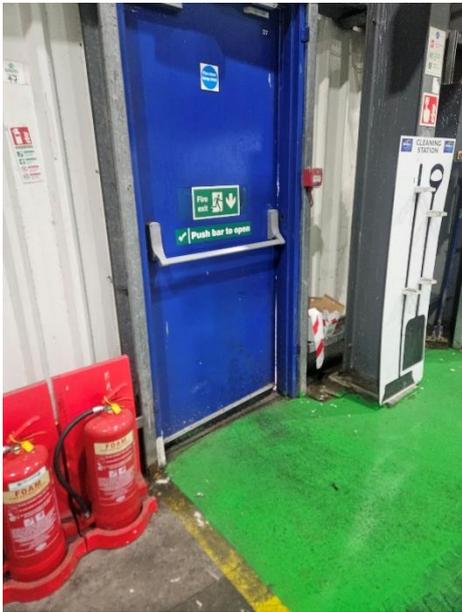
9. WAREHOUSE NO 2			
Observations	9.1 Door D7 noted to be partially open.

Recommendations	Doors should be closed when not in use to prevent pest ingress.		
Action By	CLIENT	Date Completed

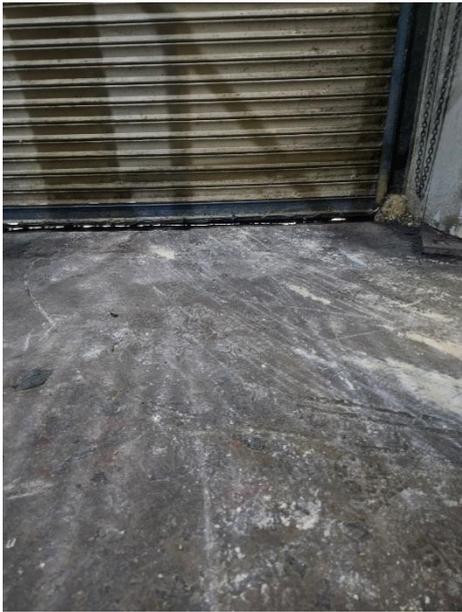
Observations	10.1 Gap noted at base of roller door.		
Photographs

Recommendations	Brush strip present but does not adequately proof door. New brush strip required.		
Action By	CLIENT	Date Completed

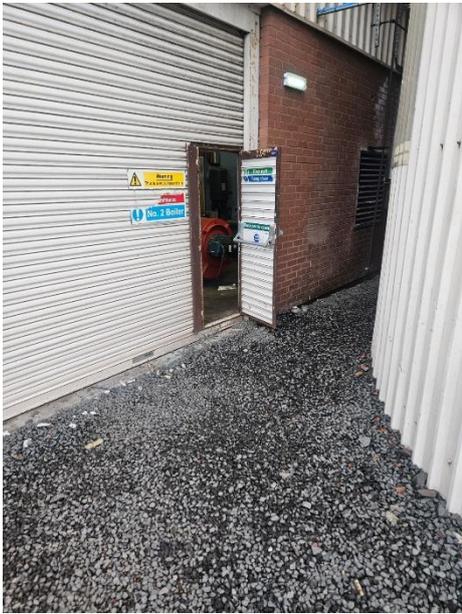
Observations	11.2 Boiler room 2 door lying open.		
---------------------	-------------------------------------	--	--

Recommendations	Doors should remain closed when not in use to prevent pest ingress.		
Action By	CLIENT	Date Completed

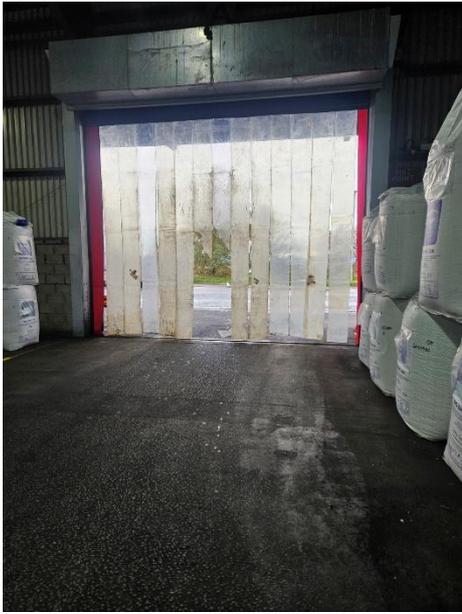
13. WAREHOUSE A- E			
Observations	13.1 Roller door A lying open and strip curtains damaged.		
Photographs

Recommendations	Repairs to door required to ensure pests cannot gain access.		
Action By	CLIENT	Date Completed

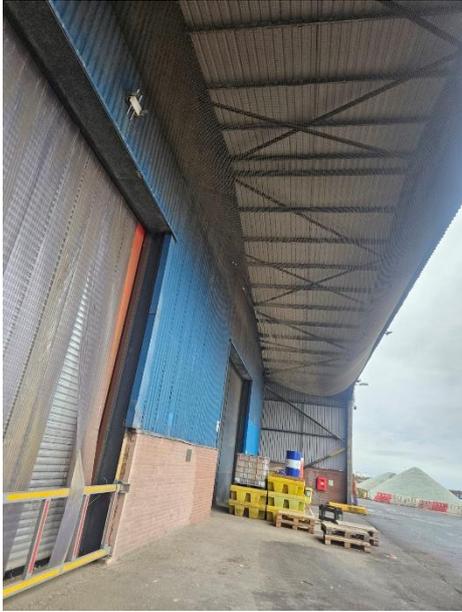
14. WAREHOUSE F			
Observations	14.1 Netting at rear canopy damaged allowing birds to gain access.		
Photographs

Recommendations	Repairs to netting required to exclude birds from area.		
Action By	CLIENT	Date Completed

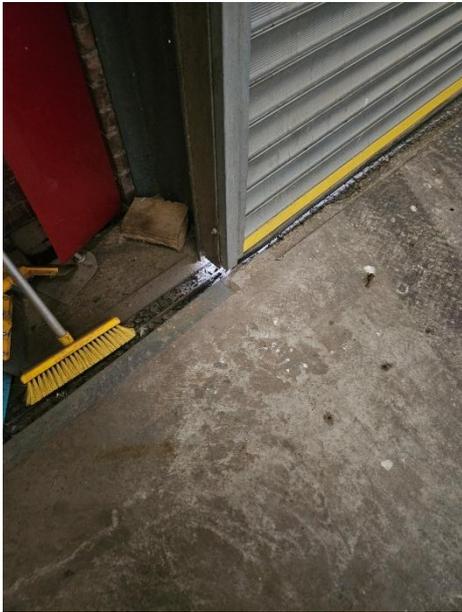
15. SHEDS R1-R3			
Observations	15.1 Gap noted at corner of roller shutter door at door R2		
Photographs

Recommendations	Gaps should be sealed to reduce risk of pest ingress.		
Action By	CLIENT	Date Completed

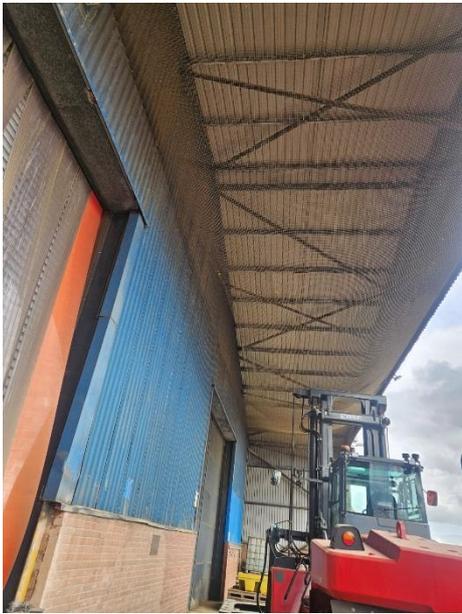
16. EXTERNAL AREAS	
Observations	16.1 As above netting at rear canopy of external warehousing noted to be damaged.

Recommendations	Repairs required to exclude birds from area.		
Action By	CLIENT	Date Completed
