**Address:** Nairn's Oat cakes  
90 Peffermill Road,  
Edinburgh,  
EH16 5UU

**Date:** 30.01.2026

### **FIELD BIOLOGIST INSPECTION**

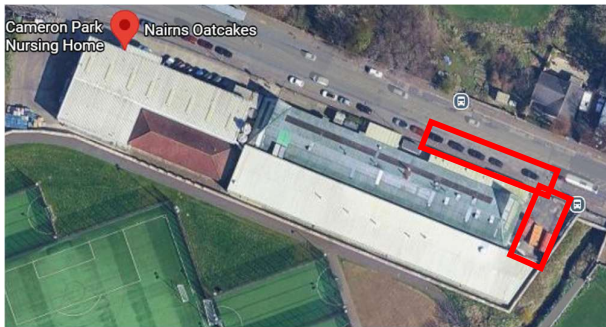
Areas where rat activity was observed at the time of the inspection are highlighted in red.

Brown rats *Rattus norvegicus* activity was observed externally around the compactor/ bin area highlighted above in figure 1. Rat footprints were also observed in silt on the road at the front elevation of the building. The environment around the factory has a high carrying capacity due to the river embankment providing opportunity for burrowing and the availability of food from the compactor/ waste bins.

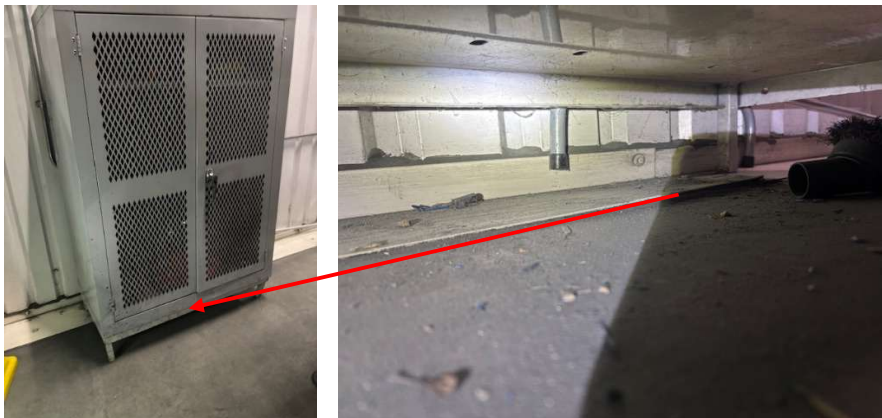
Debris was found gathering in the warehouse under the cleaning equipment locker. Please clean this area to allow for inspection and to remove potential food sources for insects. **Medium**

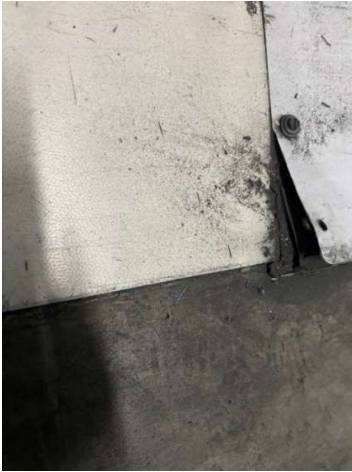
The L shaped metal plate at the floor wall junction in the warehouse adjacent to bait point 29 has been damaged, this presents a trip hazard and may allow food debris to become trapped. Please repair to deny harbourage. **Medium**

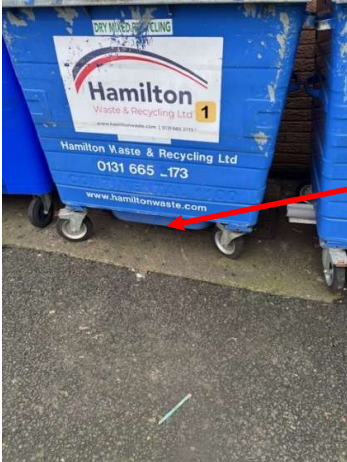
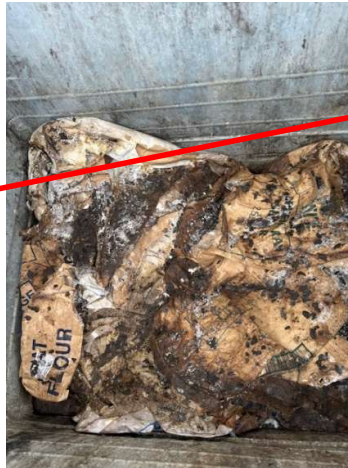
Universal bin bung

The drainage bungs were found missing from the base of the bins, this is allowing the rats to enter the bins and gain access to food stuffs. Please clean out the bins disposing of the waste and replace/ get alternative bungs for the base of the bins. **High**

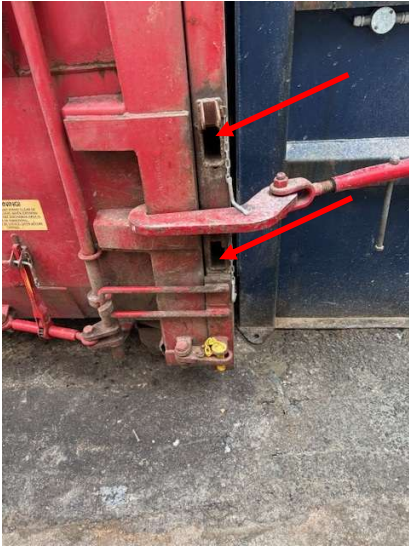
Gaps were observed between the compactor and where the transit bars are inserted allowing rats to gain access to food waste. An alternative type of compactor should be sought, or caps should be fabricated to deny rat entry into the compactor. **High**

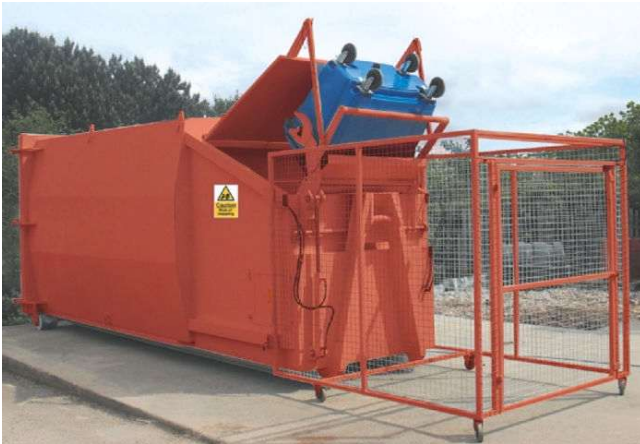
An example of a waste compactor that is fully enclosed to deny rodent entry.

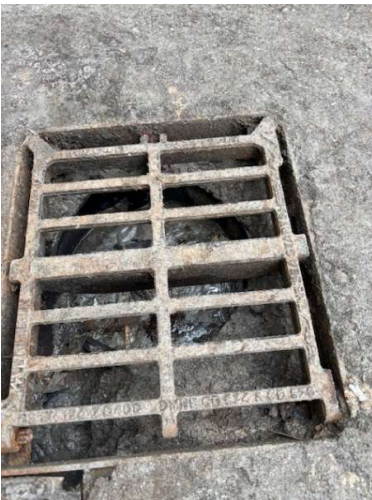
The surface water drain adjacent to the compactor requires cleaning to allow inspection and free flow of water. **Medium**
