JOHN G RUSSELL
WARDPARK
CUMBERNAULD
27/02/2026

FIELD BIOLOGY REPORT No: 10
Field Biologist: Rebekah Simpson

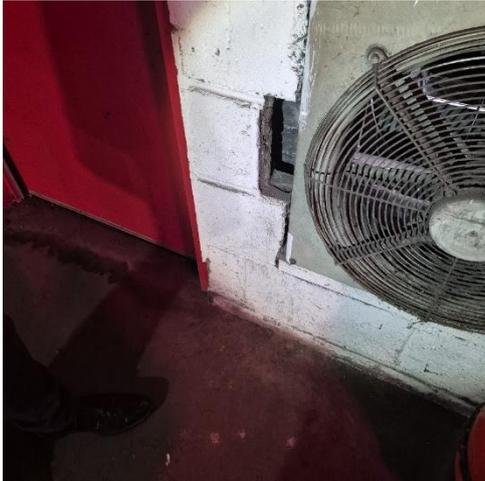
Observations	Brick missing from wall.		
Photographs

Recommendations	Please ensure gap is suitably filled to prevent rodent ingress.		
Action By	CLIENT	Date Completed

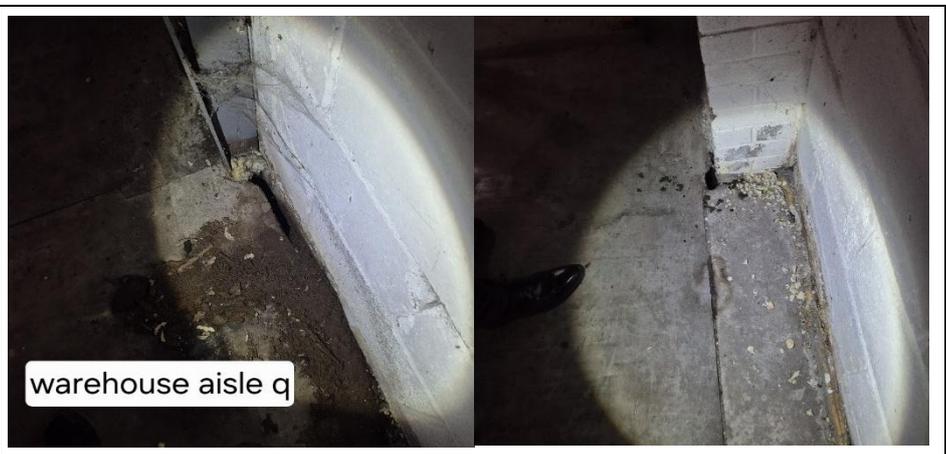
Observations	4.1 Gap noted at wall/floor junction		
---------------------	--------------------------------------	--	--

Recommendations	Gap should be filled to reduce risk of pest ingress.		
------------------------	------------------------------------------------------	--	--

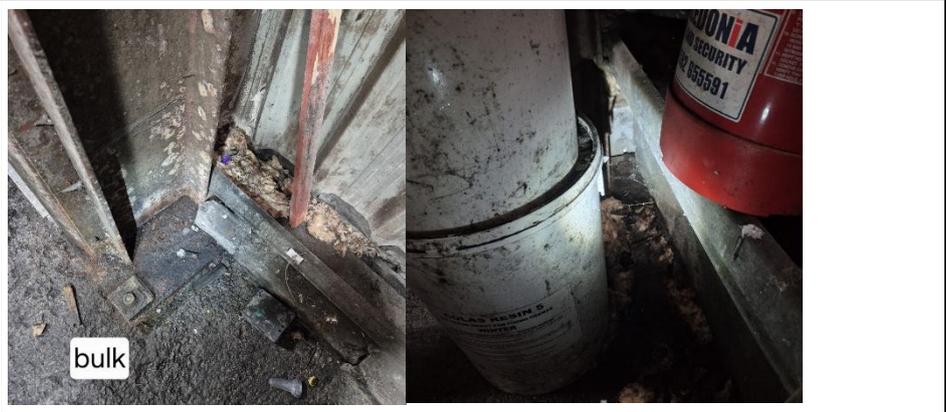
Observations	4.2 Bulk area gaps around roller shutter doors leading into wall cavity.		
---------------------	--------------------------------------------------------------------------	--	--

Recommendations	Block any points around the roller shutters to prevent rodent ingress.		
------------------------	------------------------------------------------------------------------	--	--

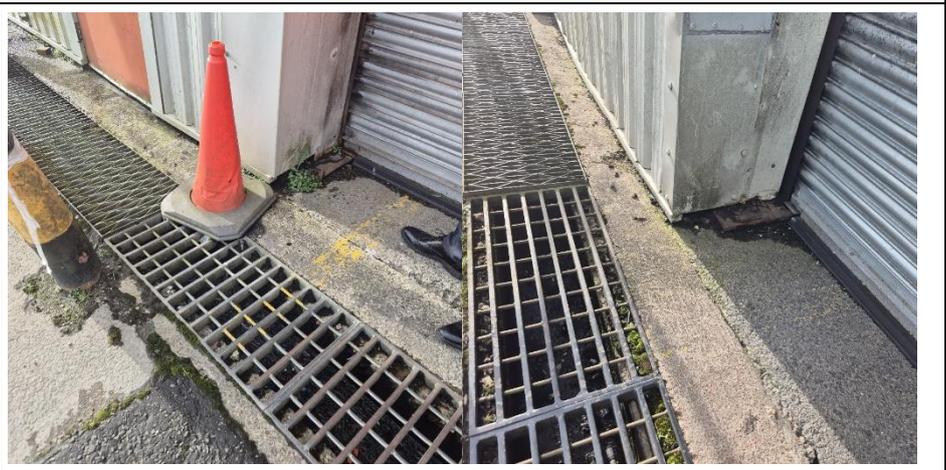
Observations	5.1 External at roller shutter doors damaged, gap would allow access into wall cavity.		
---------------------	----------------------------------------------------------------------------------------	--	--

Recommendations	Gap should be sealed to reduce risk of pest ingress.		
------------------------	------------------------------------------------------	--	--

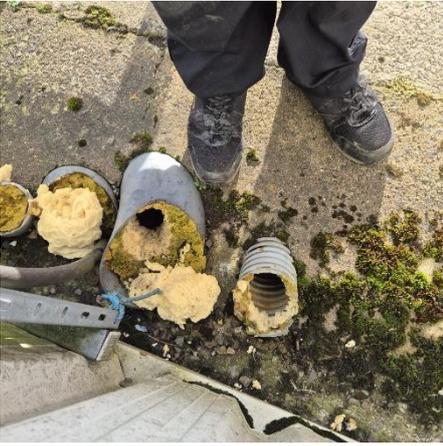
Observations	5.2 Expanding foam needs to be replaced.		
---------------------	------------------------------------------	--	--

Recommendations	These gaps should be sealed to reduce risk of pest ingress through cable runs.		
Action By	CLIENT	Date Completed	
Observations	5.3 Burrowing evident around decking area. (historical)		
Photographs

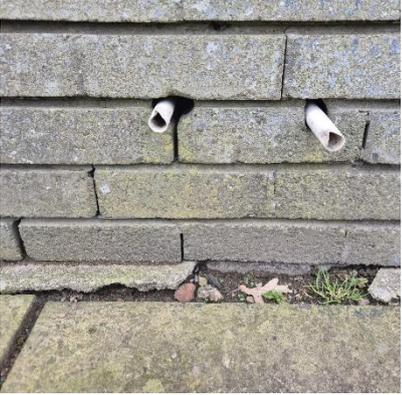
Recommendations	Please look to remove this decking area as this is perfect nesting area for rodents.		
Action By	CLIENT		
Observations	5.4 Gaps around external pipework large enough to allow rodent ingress.		
Photographs

Recommendations	Seal off gaps to reduce risk of pest ingress.		
Action By	CLIENT		
Observations	Open drainage pipework.
