Address: Nairn's oatcakes
Unit 15 Butlerfield Ind Est
Bonnyrigg
EH19 3JQ

Date: 09.02.2026

FIELD BIOLOGIST INSPECTION

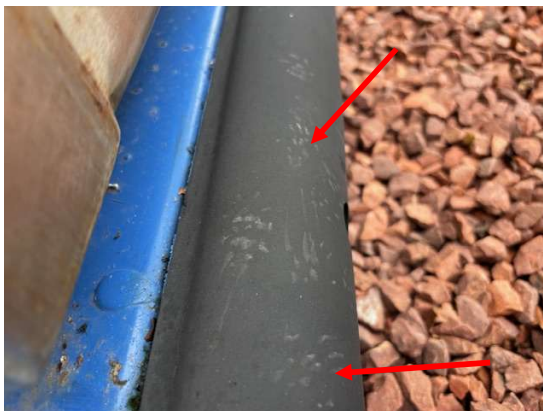
Rat footprints were found on the rubber bumper at the base of the chiller door. No damage was seen to the base of the door.

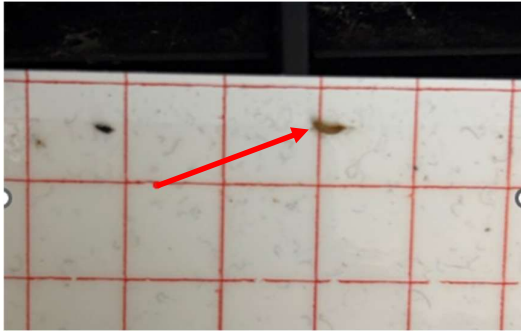
Insect activity was observed at the time of inspection, insect detector 13 situated next to the disused Redpack Pacer packing machine. The larval species was identified as *Dermestidae spp.* Insect pheromone traps have been ordered and will be installed.

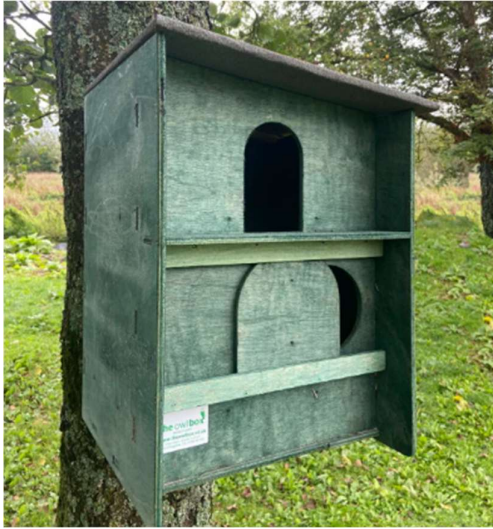
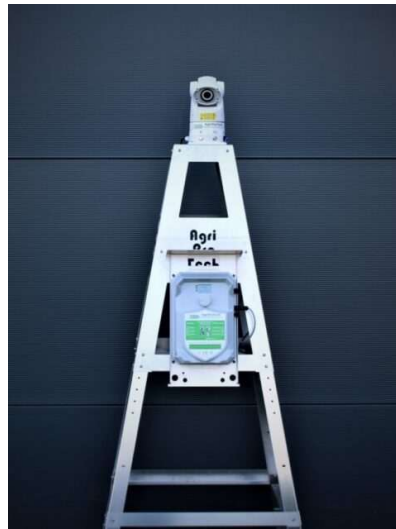
No bird activity was observed at the time of inspection; the gull nesting season has not begun yet. Raptor boxes could be installed around the site on posts to encourage biodiversity and function as a predatory threat to gulls, rabbits and rodents. Excel can provide a quotation for the raptor boxes and a laser/ bio acoustic system to discourage bird from nesting on the roof.

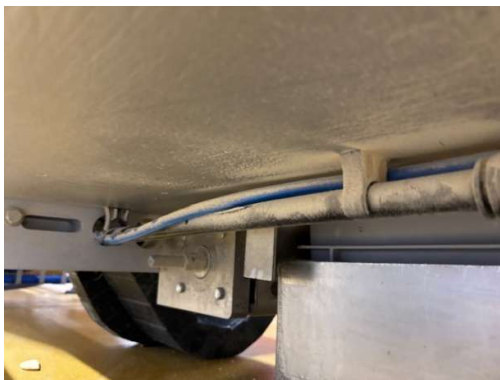
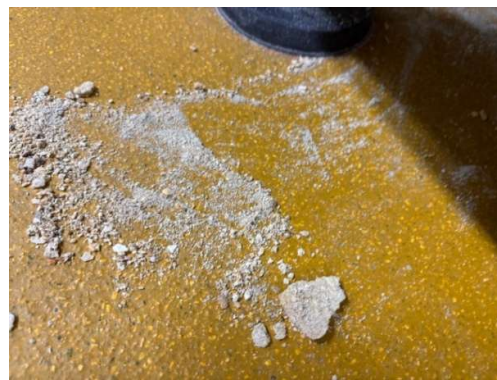
Food debris was found within and under the disused Redpack Pacer packing machine, this will require cleaning to reduce the potential for stored product insect (SPI) infestation. **High**

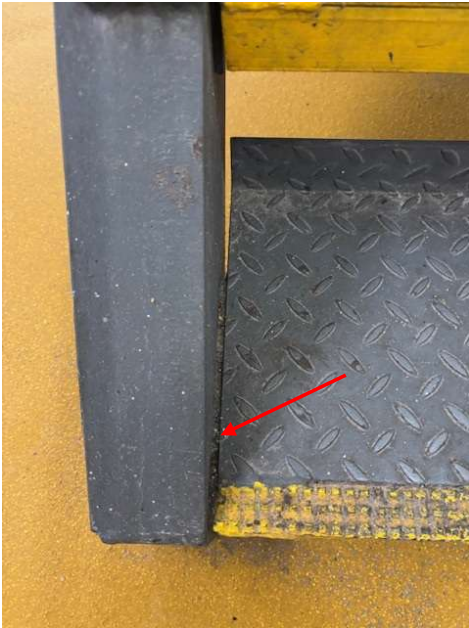
Food residue was found gathering in the sides of the steps leading to the cooling area. Please clean and weld closed or fill with a cold weld epoxy filler. The cold weld epoxy filler will reduce disruption to production. **Medium**

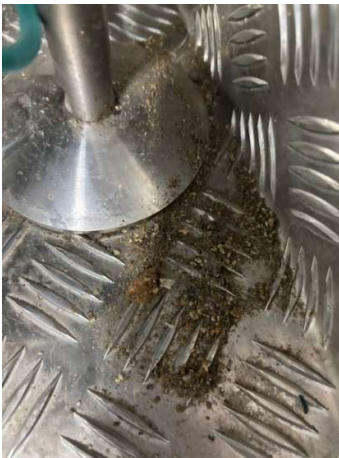
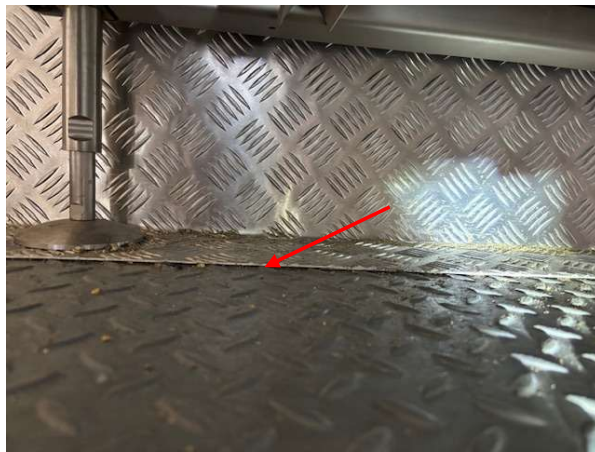
Food residues were found collecting at the footings of the control panel on the Mezzanine floor. A gap was also found under the checker plate floor wall interface proving potential areas where food can collect and insects can harbour. Please clean this area and block the gap between the floor and checker plate. **High**

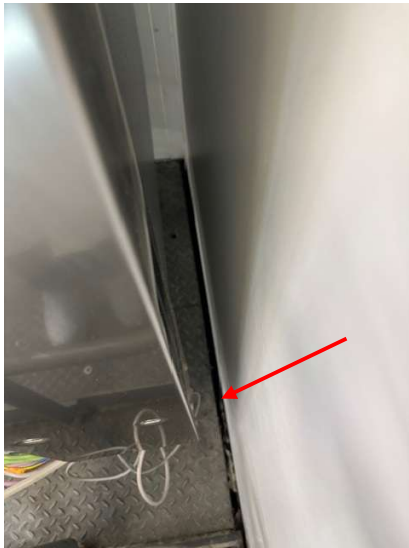
A large gap was found at the rear of the control panel on the cooling mezzanine floor. Please clean and block this area with a covered section to prevent the accumulation of debris denying harbourage for insects. **Medium**

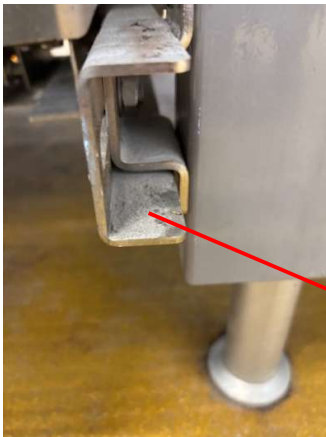
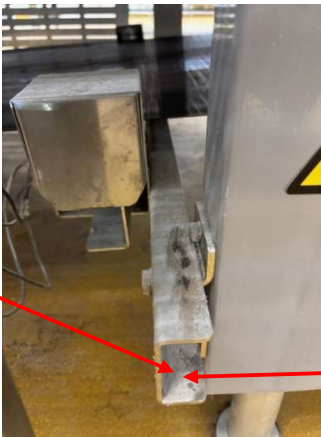
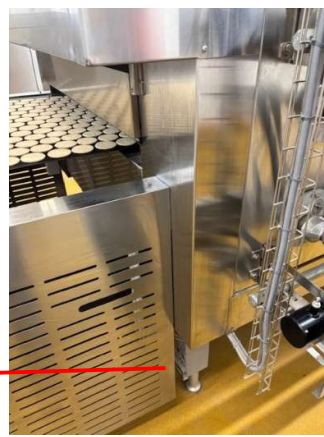
Powder residue was found collecting on horizontal surfaces under the Buhler line 2. **High**

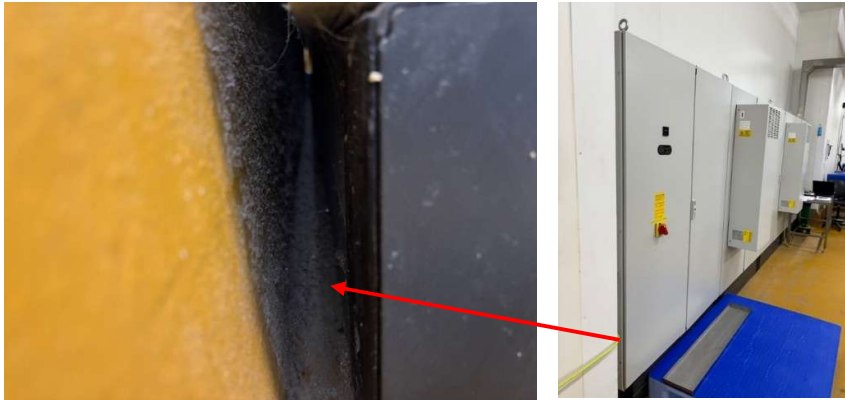
Powder residues were found collecting down the side of the control panel next to line 2. Please clean with a high efficiency particulate air (HEPA) vacuum cleaner to remove the residues. **High**

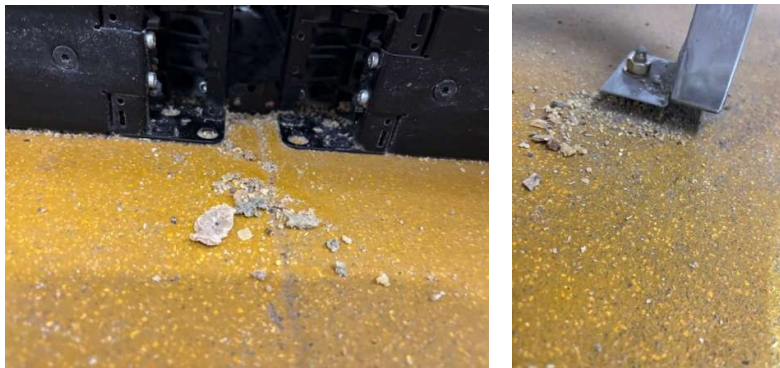
Food debris was found gathering at the Gluten free line control panel and at the footing of the steel ladder. Please clean and block the base of the control panel and footings of the ladder. **High**

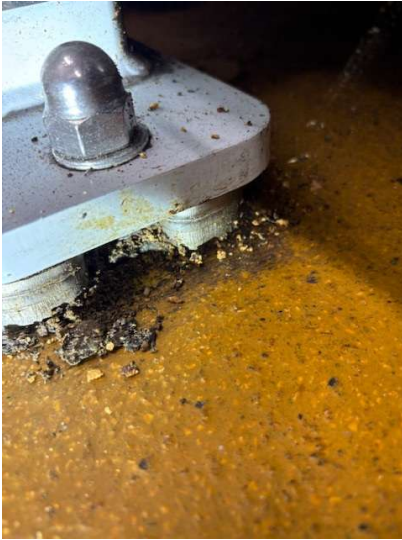
Debris was found collecting at the footings of the Buhler line 2. Please clean to reduce potential for SPI activity. **High**

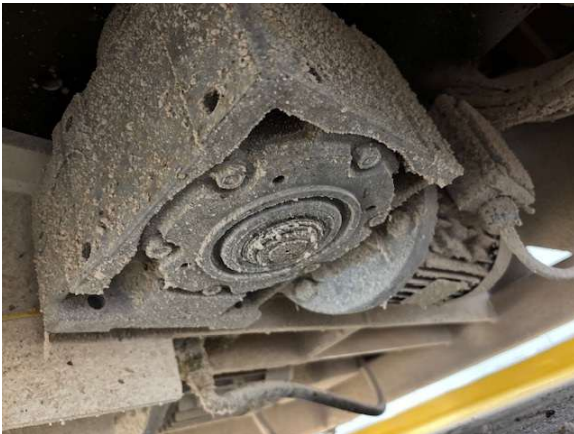
Food debris was found collecting around the motor housing under the large mixers on the mixing mezzanine floor. Please clean to help prevent insect proliferation. **Medium**

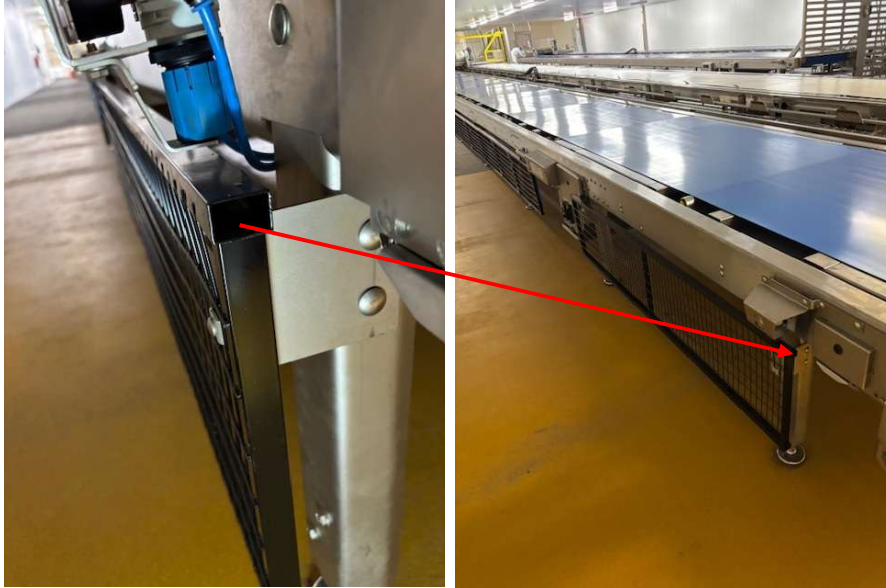
Caps were found missing from the tubular metal guards on the drying belt located on the mezzanine floor. Please source end caps to blank the ends off denying pest harbourage and food residue collection. **Low**

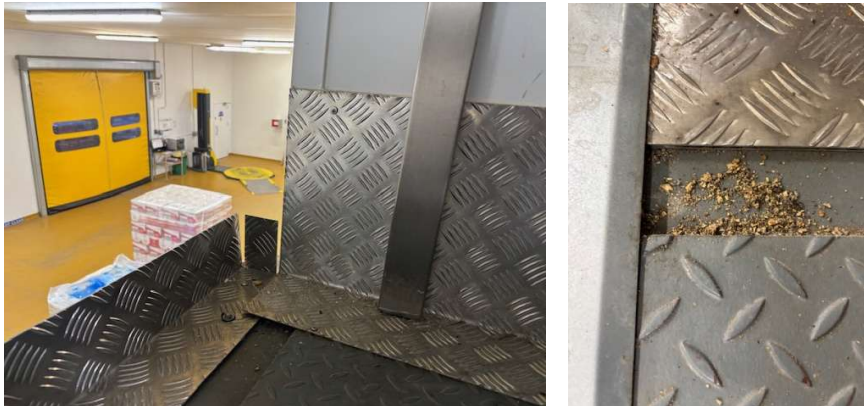
The checker plate flooring on the mezzanine floor is poorly finished in some areas preventing thorough cleaning and facilitating the collection of food debris. Please remedy to deny potential insect harbourage and facilitate cleaning. **High**

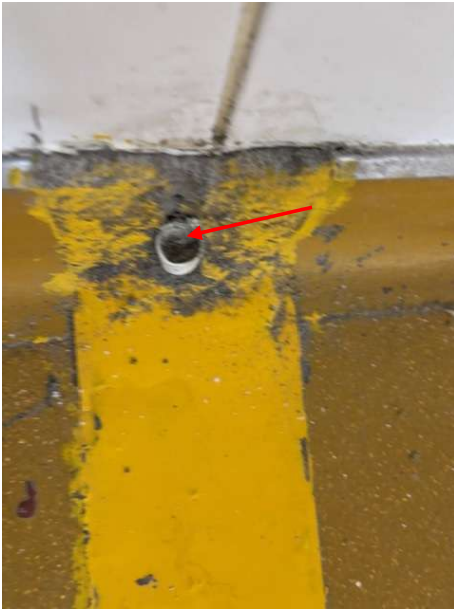
An old piece of plastic conduit was found under the stairs leading to the upper mixing area adjacent to gluten free line 2. The conduit has been filled; however, this has become pushed in allowing scope for food material collection. Please cut flush and fill with an epoxy resin. **Medium**

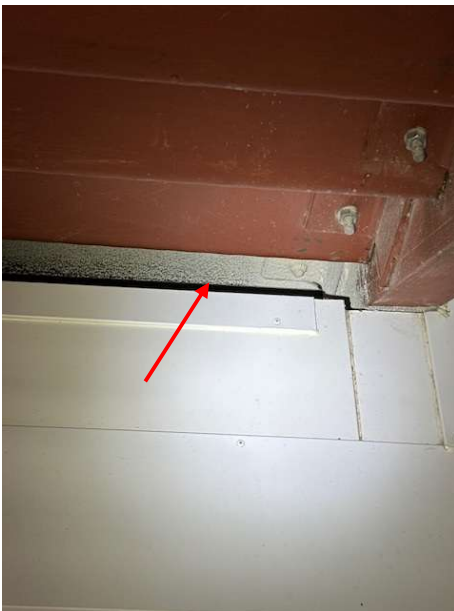
A gap between the top stair leading to the mixing area and the floor void, the area requires cleaning and sealing to prevent powder residue being drawn in via negative air pressure. The dead space and residues may aid in the proliferation of SPI. **High**

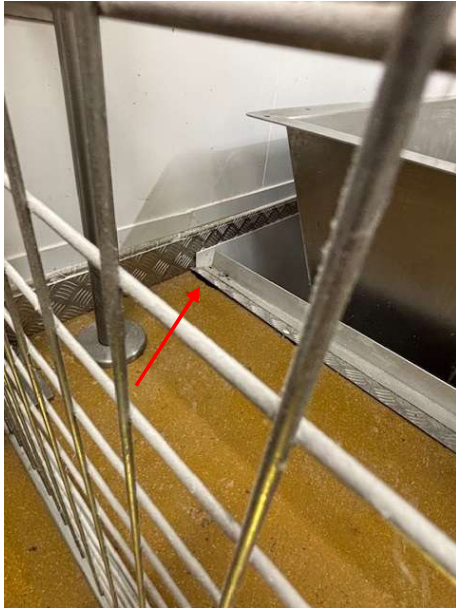
Damage has occurred to the checker plate and the concrete flooring in the mixing area. Please repair to prevent the accumulation of food materials and allow cleaning. **High**

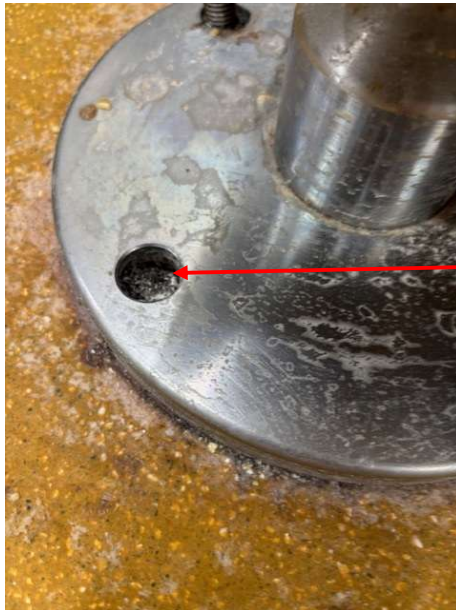
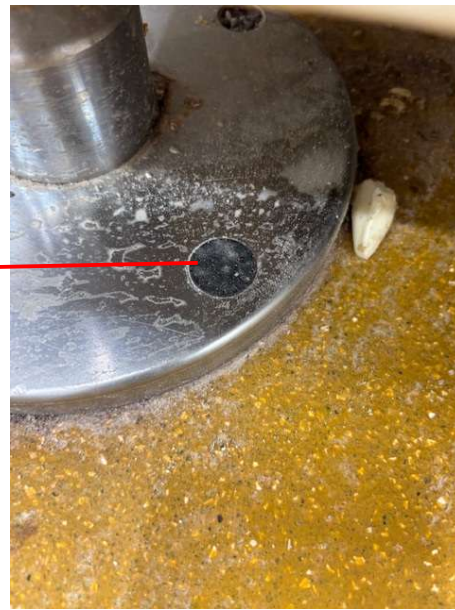
Blanking caps were found missing on the mixers situated on the mixing mezzanine floor. Please replace to prevent water and debris accumulation. **Medium**

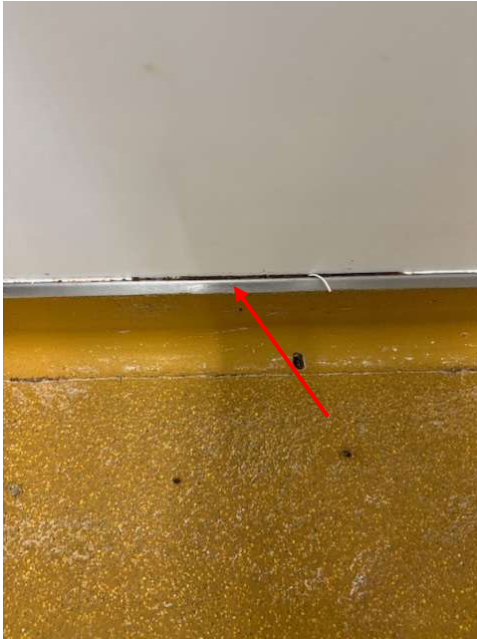
The silicon sealant at the coving wall interface has become loose, water and food residue may become trapped in this area. The defect was found on the mixing mezzanine floor. **Medium**

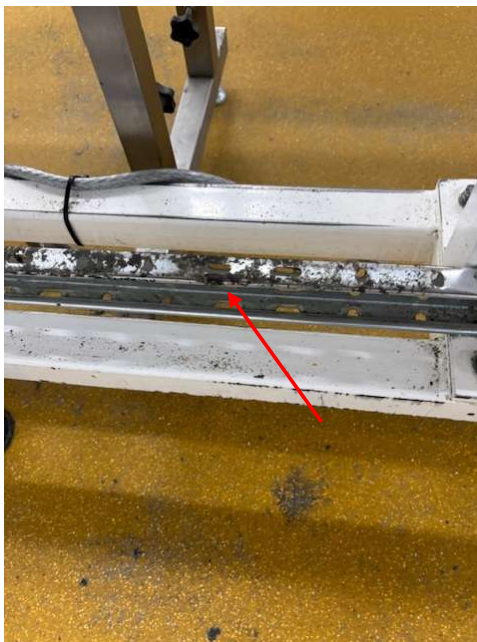
Staff are placing their footwear on the cable tray of the Redpack Pacer packing machine GF1-9075. Please clean this area and instruct staff to change this practice. **High**

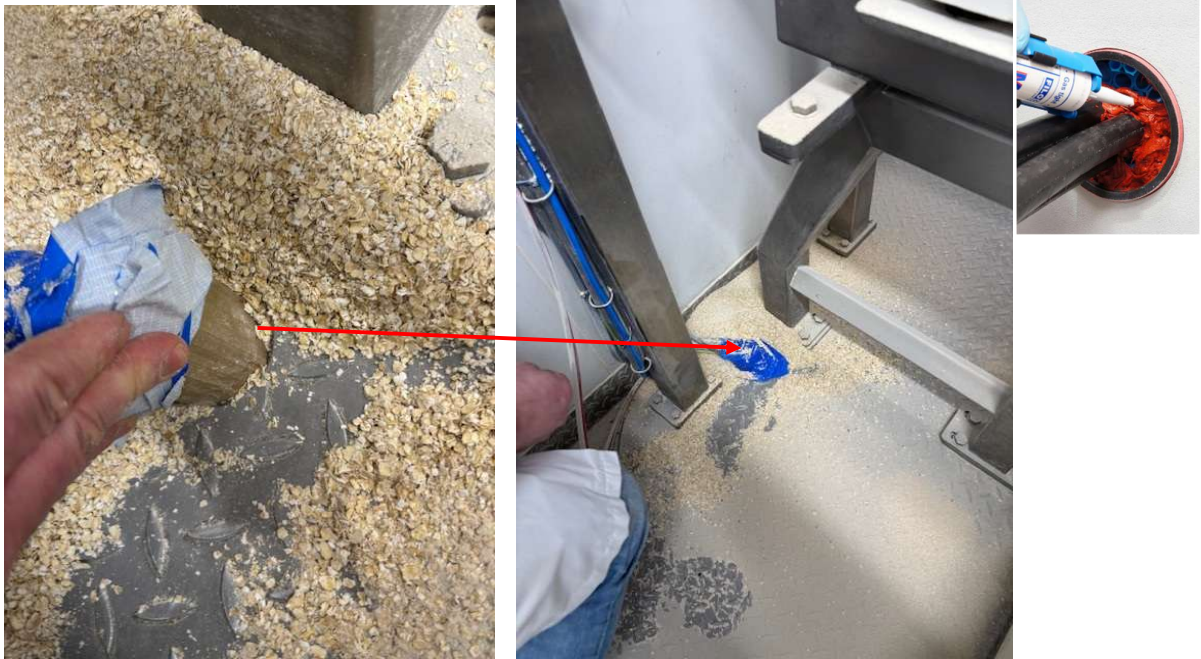
The gap around the cables from the weighing hopper requires sealing to prevent the accumulation of dried cereal product as this may facilitate the proliferation of insects. Please seal with a better product such as filoseal+HD. <https://www.filoform.com/product/filoseal-hd-duct-seal/> **High**

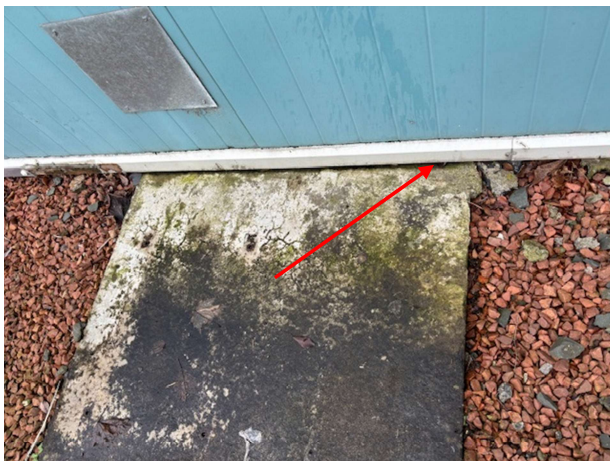
Gaps are present under the flashing at the left-hand elevation of the building; this defect may allow rodent ingress into the wall cavities. The defect should be proofed with rodent proof material such as Xcluder rodent mesh and cement. Excel can provide a cost for this work. **High**
