PEACOCKS
NORTH HARBOUR STREET
AYR
13/03/2025

FIELD BIOLOGY REPORT No: 19
Field Biologist: Christopher Gahagan

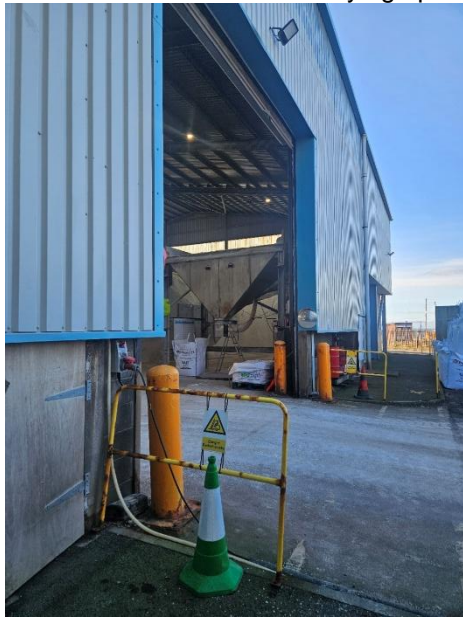
8. SALT STOCKPILES

Observations	<p>8.1 Roller doors found to be lying open and unattended.</p>

Recommendations	Open doors allow easy access for pests, doors should be closed when not in use.		
Action By	Client	Date Completed
